Test Report No.: CE/2018/10664 Page: 1 of 5 Date: 2018/01/08

TAIYO INK MFG. CO., LTD.

Sample Description : PSR-4000 LEW5/CA-40 LEW5 (UL:PSR-4000KB/CA-40KB)

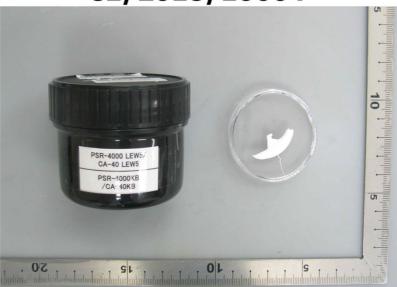
CE/2018/10664

* The tested sample / part is marked by an arrow if it's shown on the photo. *
